# SHILTON CAST IRON & WELDING LTD

## Pump Casing Bottom Half

**Pump Casing Top Half**

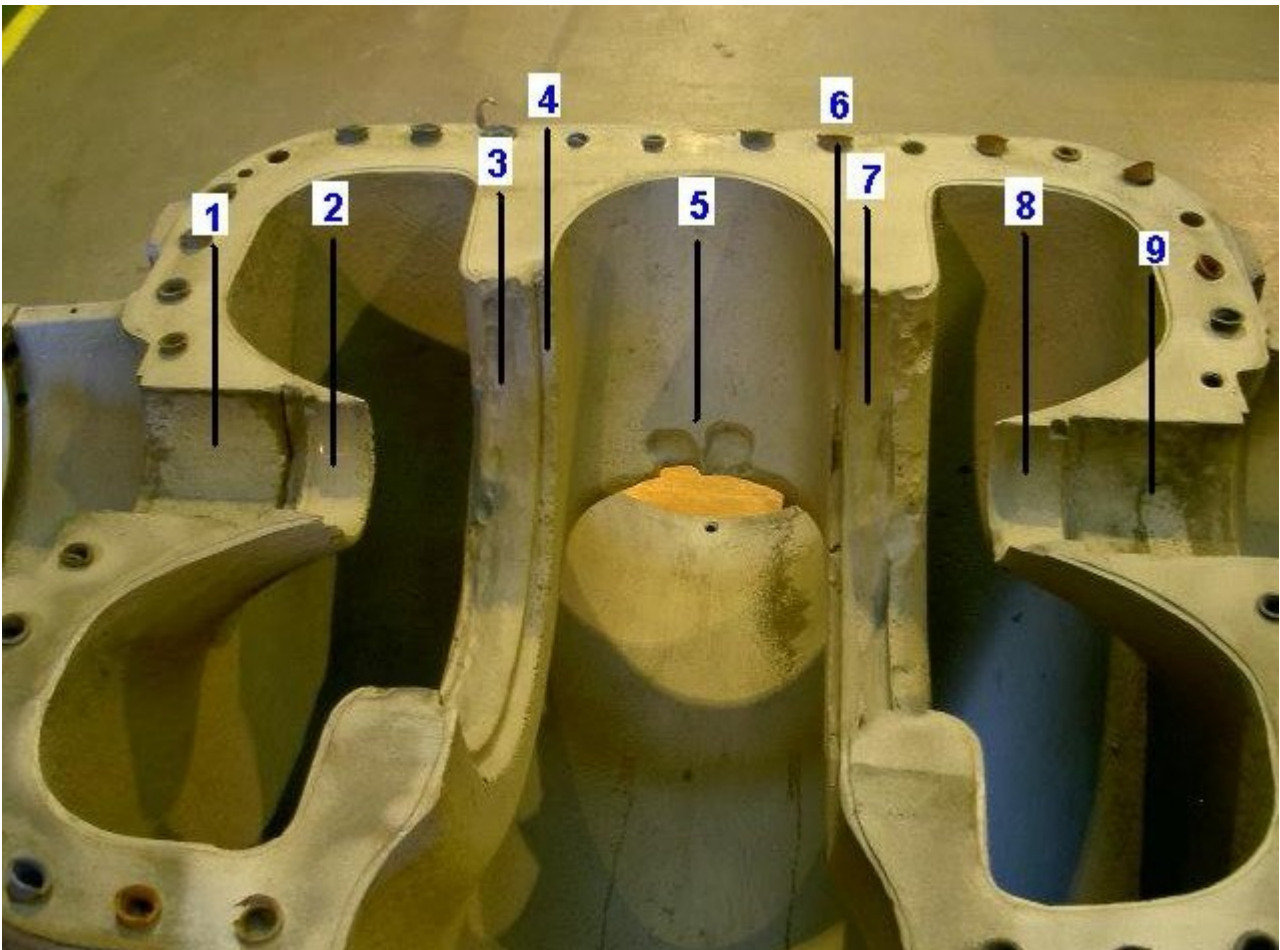
## Damaged locating Diameters

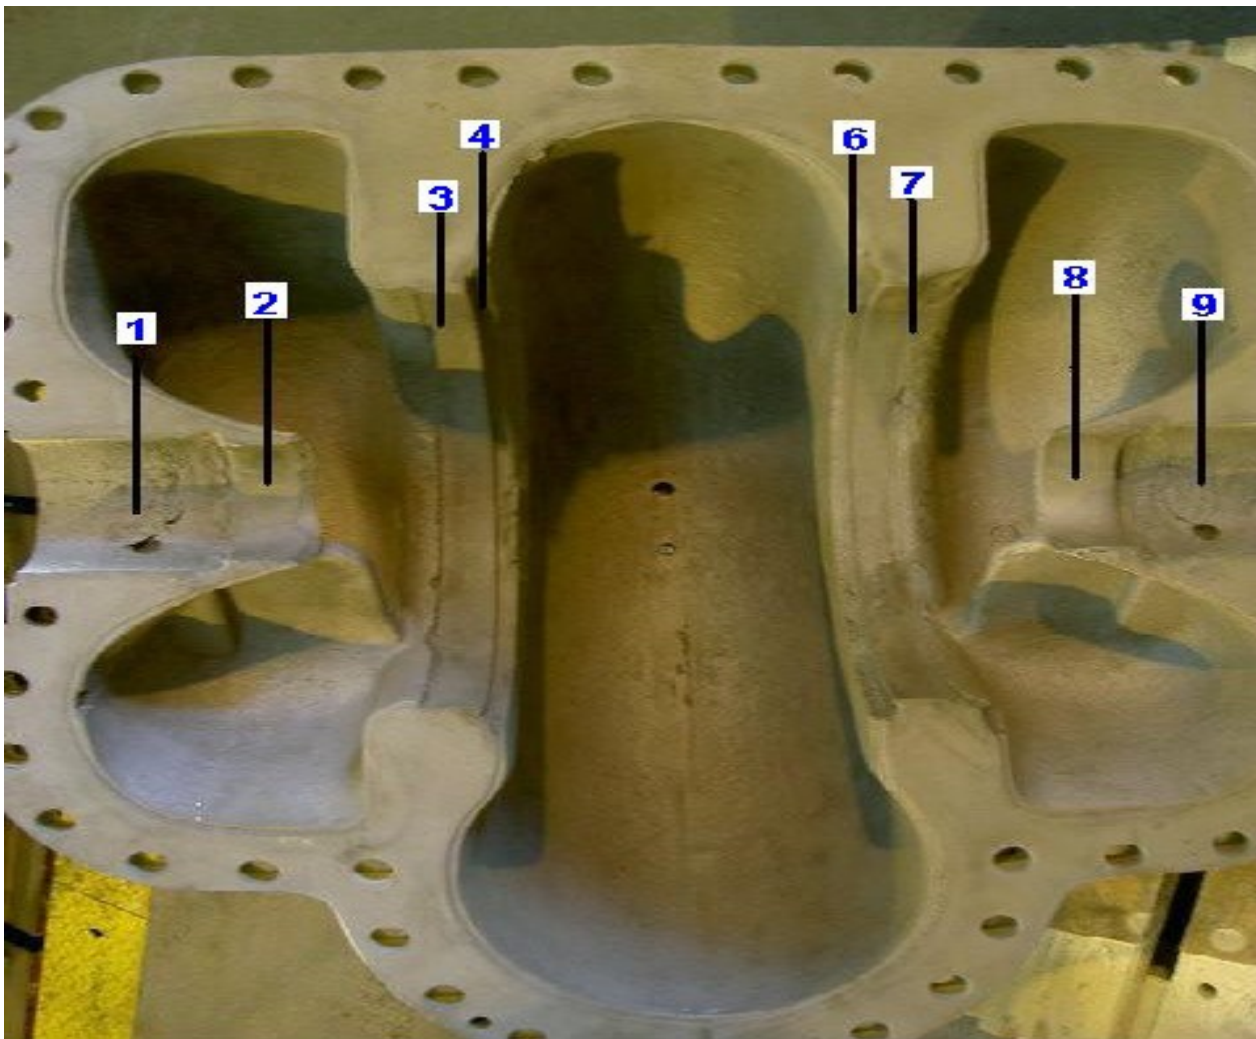
## Damaged locating Diameters
